Manhole Inspection Summary

Manhole # S23GG1006MH

Location Address: **4149 Buena Vista Ave**

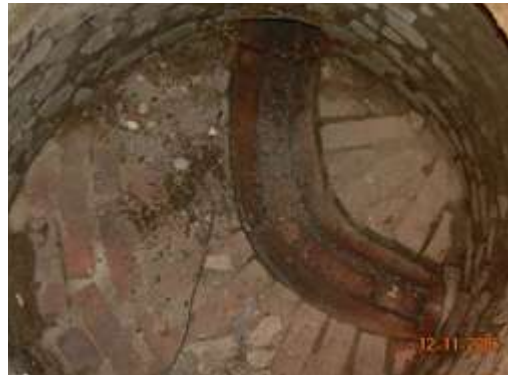
Top View

Adjustment, corbel, and barrel infiltration

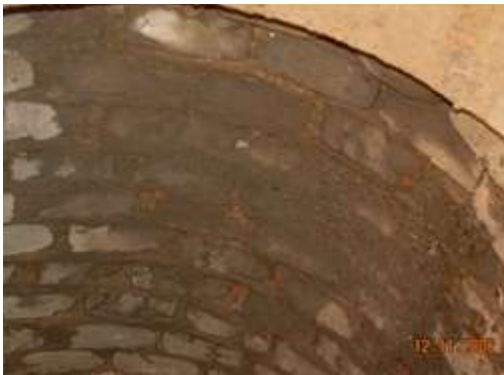
Defect

Infiltration: ☐ None ☒ **Joint** ☐ Cracks ☒ **Mortar** ☐ Roots ☐ Wall

Adjustment infiltration

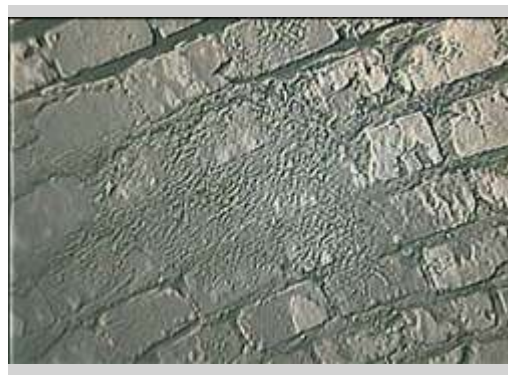
Defect

Comments **Buena Vista Ave (back yard). The I4 pipe picture shows Barrel deterioration.**

Condition: ☐ Sound ☐ Cracked ☐ Root Intrusion ☐ Loose Brick ☒ **Deteriorated**

Infiltration: ☐ None ☐ Joint ☐ Cracks ☒ **Mortar** ☐ Roots ☒ **Wall**

Barrel infiltration
